Manhole Inspection Summary

Manhole # S21WW1002MH

Location Address: **310 SPRINGHOUSE PATH**

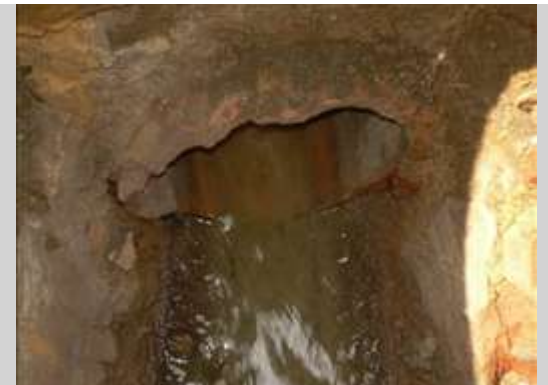
8 in. Circular Gravity Sewer Pipe In @ 3 O'Clock

Deposits: ☐ None ☐ Mud ☐ Sludge ☐ Debris ☒ **Grease**

Silt Depth: **0** (in.) Deposits Extent: **Light**
